Parts Update kit Armstrong Cab handrail holes

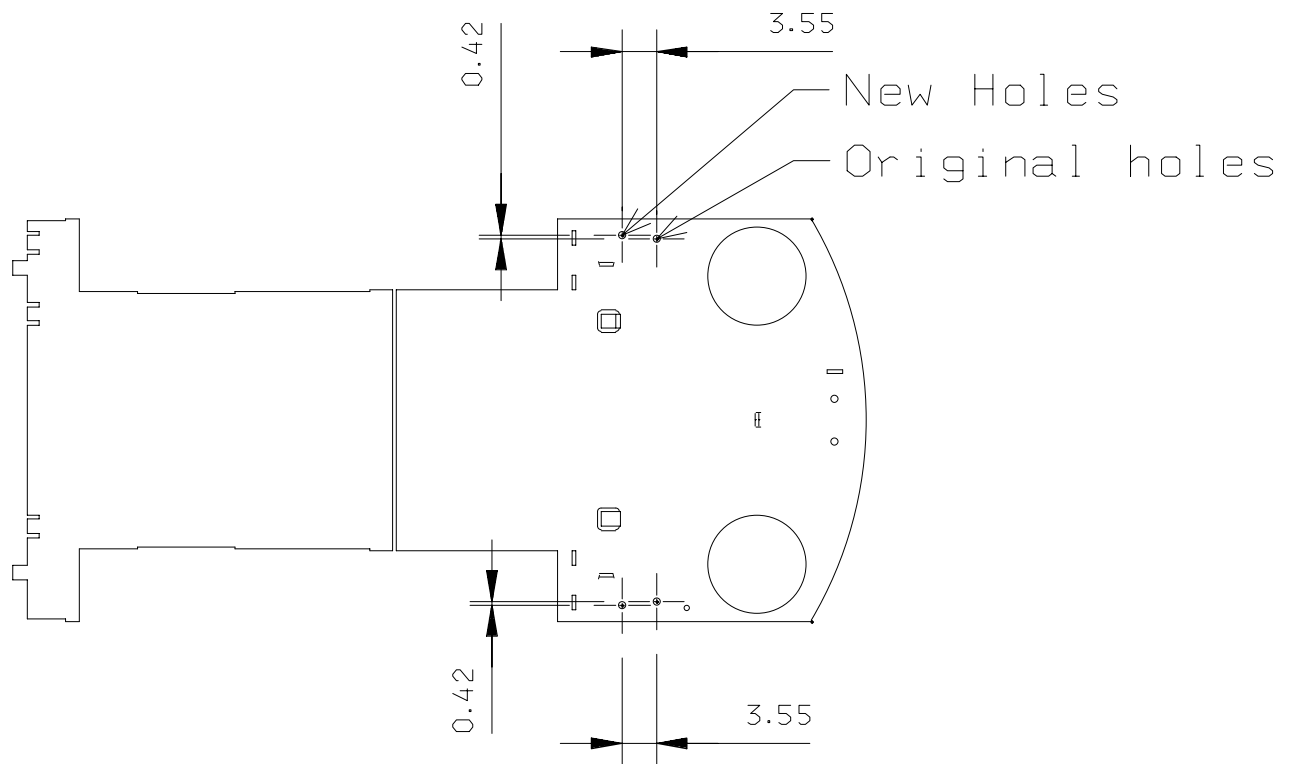
An error has come to light re the position of the cab handrail effecting parts 096 and brass overlay B003.

Please see the illustration below for positional details.

The overlay should be assembled to 096 prior to drilling.
